**Coquitlam/Buntzen Project Water Use Plan**

**Coquitlam Dam Flow Release Interim Ramping  
Rate Monitoring – Year 4 Report**

**Reference: COQMON#2**

# Coquitlam River Rampdown Summary

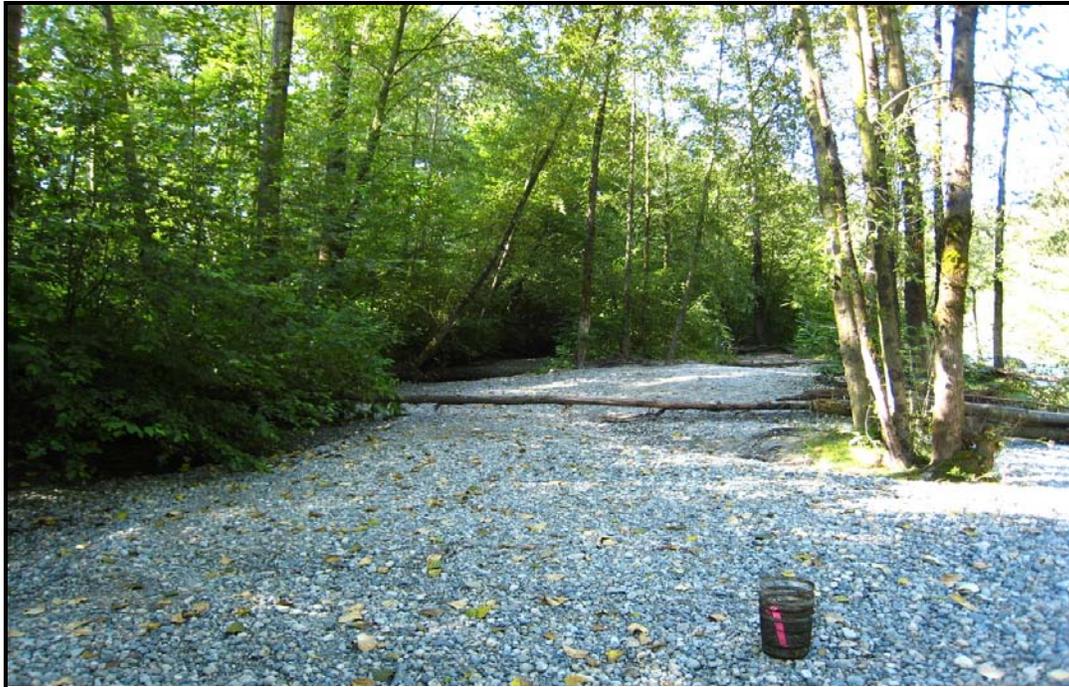
Sites A2 and A3 were not inundated during the flow release, therefore no stranding was observed in these areas. Five minnow traps were set in site A1 on May 7 at 1400hrs, and were recovered the following morning at 08:00. One chinook Fry was recovered in the traps with 21 coho fry and 9 chum fry salvaged by net. Mortalities observed in site A1 included 5 coho fry, (Table 3). Not all of site A1 was inundated during the spill, but the most problematic areas were. No new stranding areas were discovered. Table 4 shows the total fish stranded and mortalities per square metre. The total surface area of dewatered substrate in site A1 was 1450 m<sup>2</sup> resulting in 0.025 fish stranded per square metre

**Site A1:** This area is characterized by densely treed and shrubby river margins that contain many depressions that form isolated pools. The substrate is mainly soil and vegetated cover, along with some areas of exposed gravel and cobble.

**Figure 6** Site A1 showing gravel area on fluvial island where fish are regularly stranded

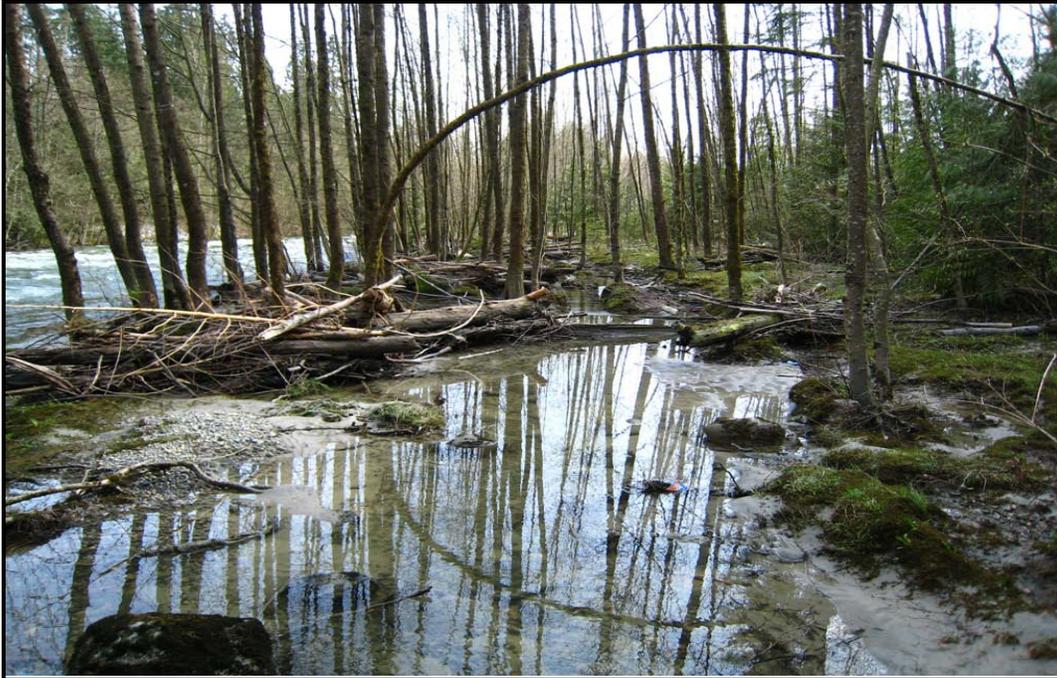
Site B2 experienced the highest rate of stranding at 0.1417 fish stranded per square metre (Table 4). During two or more gate openings the total dewatered area of B2 is approximately 3000m<sup>2</sup>. However, in a spill consisting of one LLO gate, only the upper portion of the site is inundated. This resulted in a dewatered area of approximately 120m<sup>2</sup> in Site B2 (Table 3).

**Site B2:** This area is a long narrow partially treed platform with a combined soil, gravel and vegetated substrate. It strands adults, juveniles and redds. This site only becomes inundated during a full three LLO release, and is one of the earliest sites to begin dewatering.

**Figure 7** Site B2, showing isolated pool formed during flow reduction, this site strands juveniles, adults and redds. Substrate is primarily mud and soil.

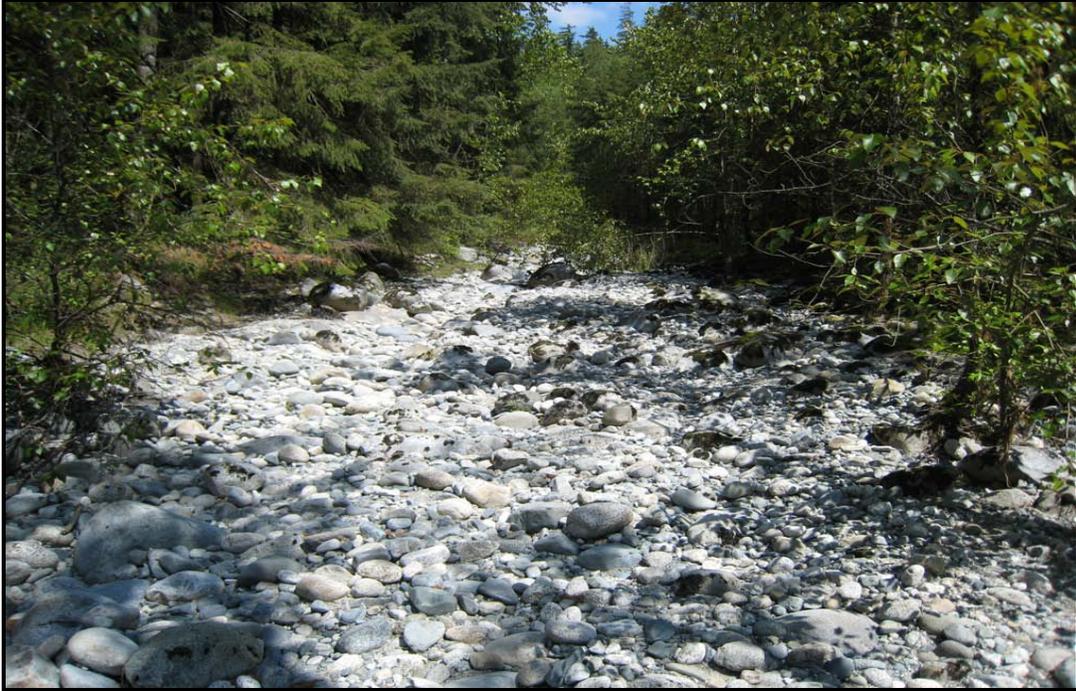
Site C1, was monitored continuously for several hours during the rampdown due to severe stranding problems. One survey crew spent over six hours at this spot salvaging fry and parr from a cobble/boulder side channel that drains rapidly. Twenty coho fry, 16 chum fry, 8 chinook fry, 1 trout smolt, 3 coho smolts and 1 lamprey, were salvaged. Mortalities observed the following day included 5 coho fry, 3 chum fry and 3 chinook fry (Table 3). Total fish stranded per square metre was 0.0870 with a total dewatered substrate area of 690 square metres (Table 3)

**Site C1:** This site is a long side channel composed of gravel and cobble substrate. It drains rapidly and forms many isolated pools that do not retain water well. This site experienced the highest number of stranding during the past two years

**Figure 8** View of site C1 side channel that is wetted during single gate openings. This site typically has the highest incidence of stranding on Coquitlam River.
